**MONTGOMERY COUNTY FIRE/RESCUE SERVICE
POST INCIDENT ANALYSIS**

**19350 Churubusco Lane
March 14, 2016**

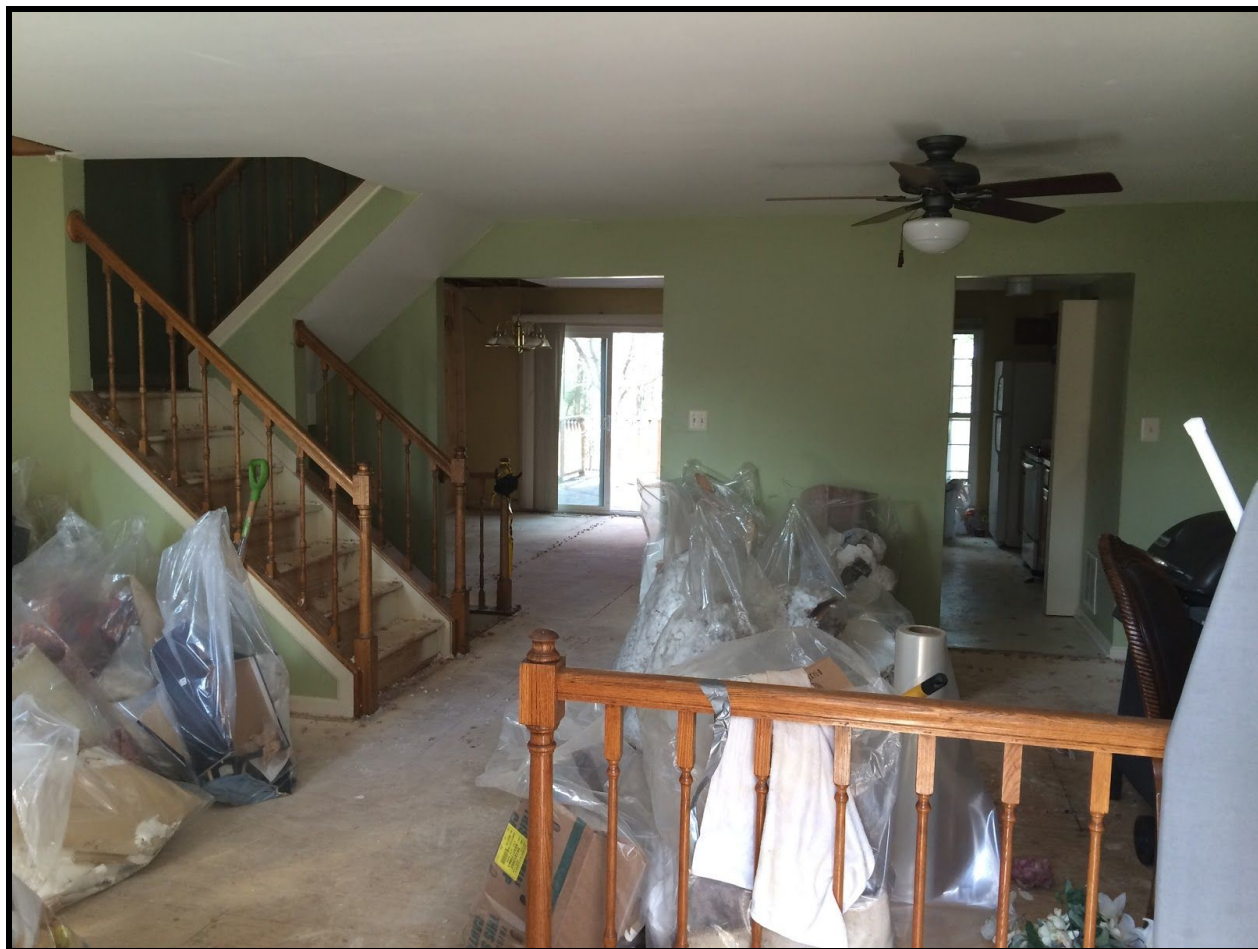
Layout of the first floor as viewed from the front door.

On the first floor Paramedic Engine 729 found that the floor was sloping from front to back, the neutral plane that was only about 3.5-4 feet off of the floor, and that of all of the water that they flowed into the overhead spaces, none of it rained back down. The crew advanced about 10 feet inside the structure under harsh conditions, this is where the nozzle person was burned.

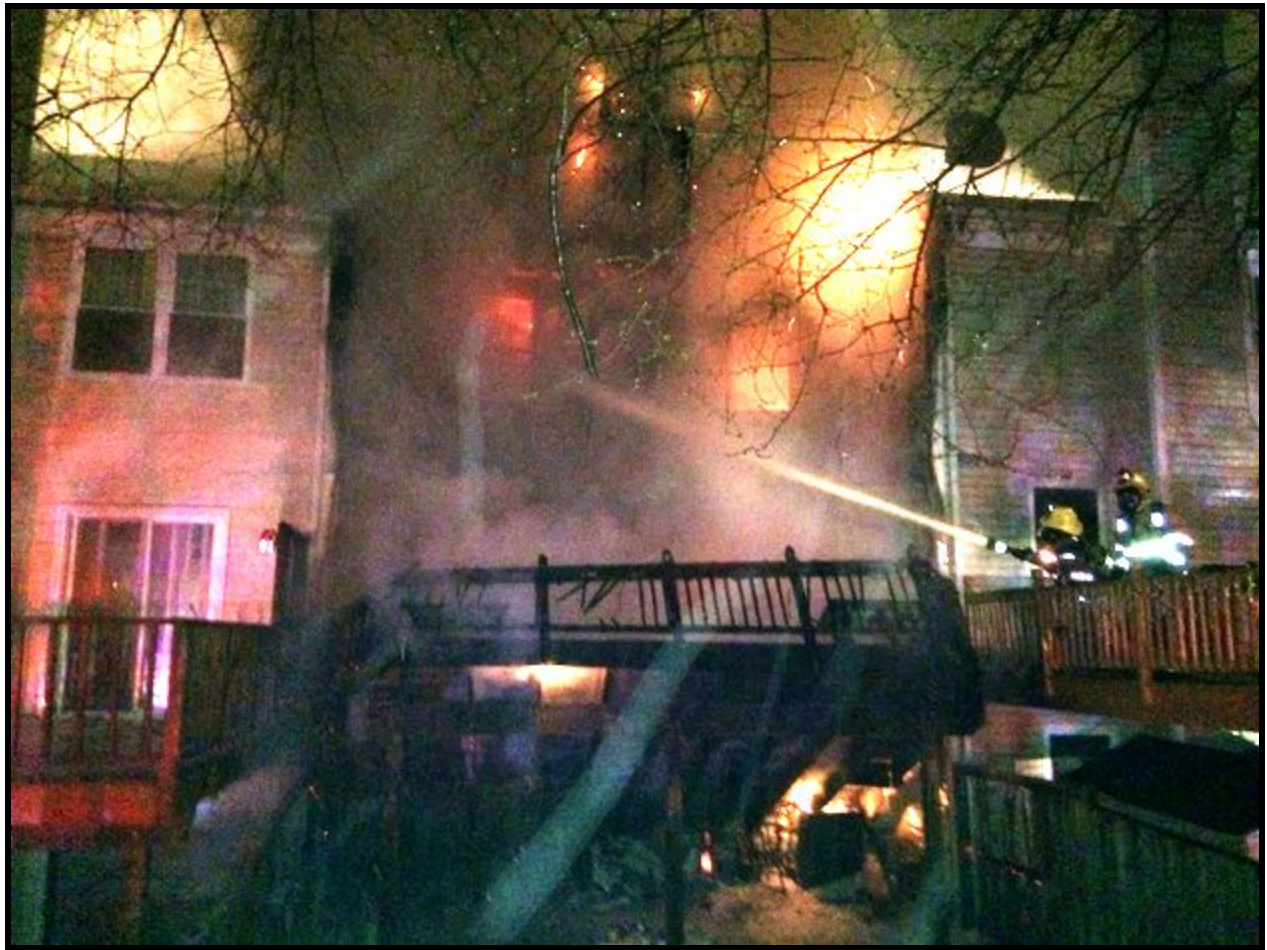
View from Side Charlie of Paramedic Engine 734 attacking the fire.

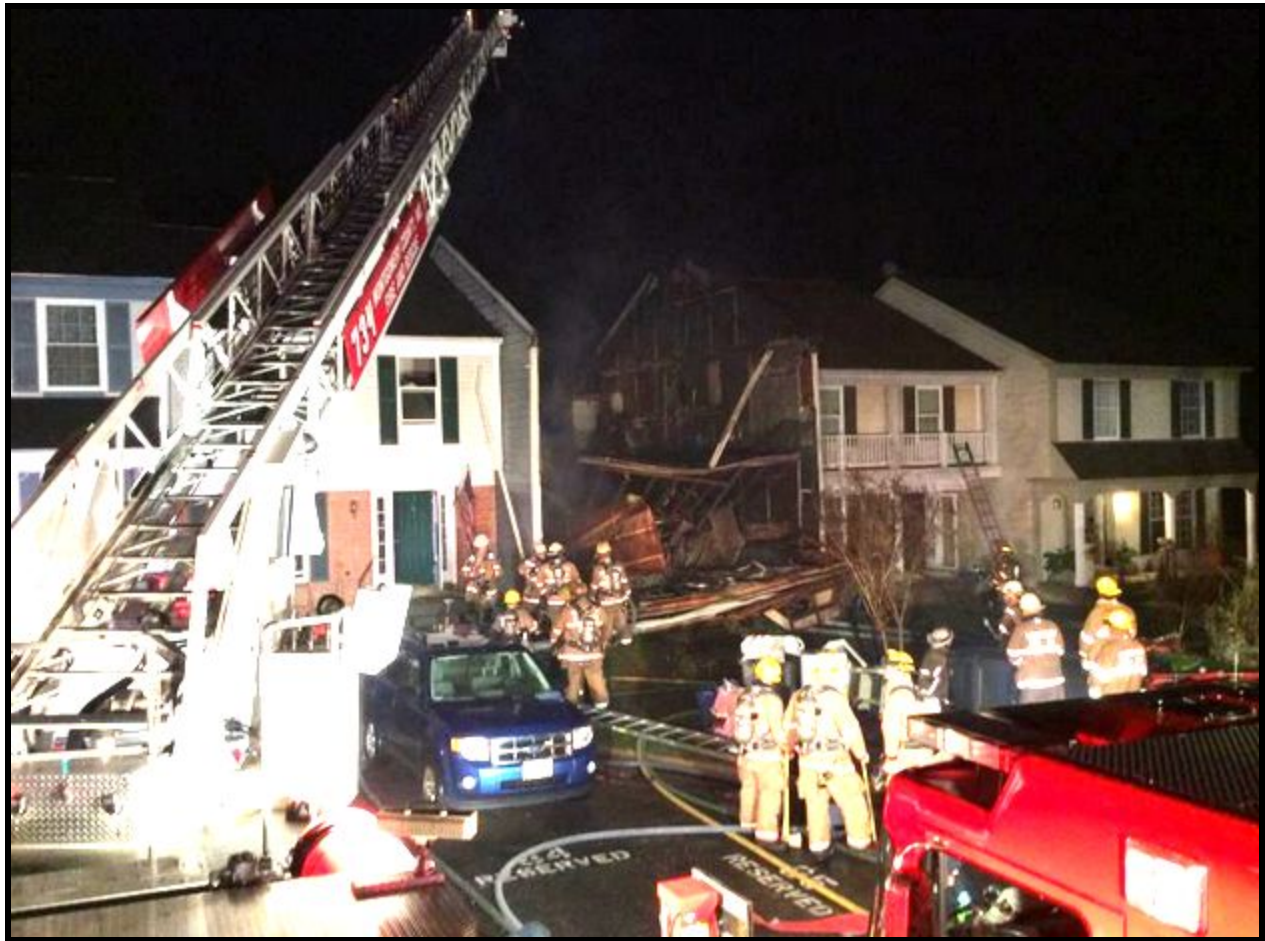
View from Side Alpha after the Mayday was resolved.

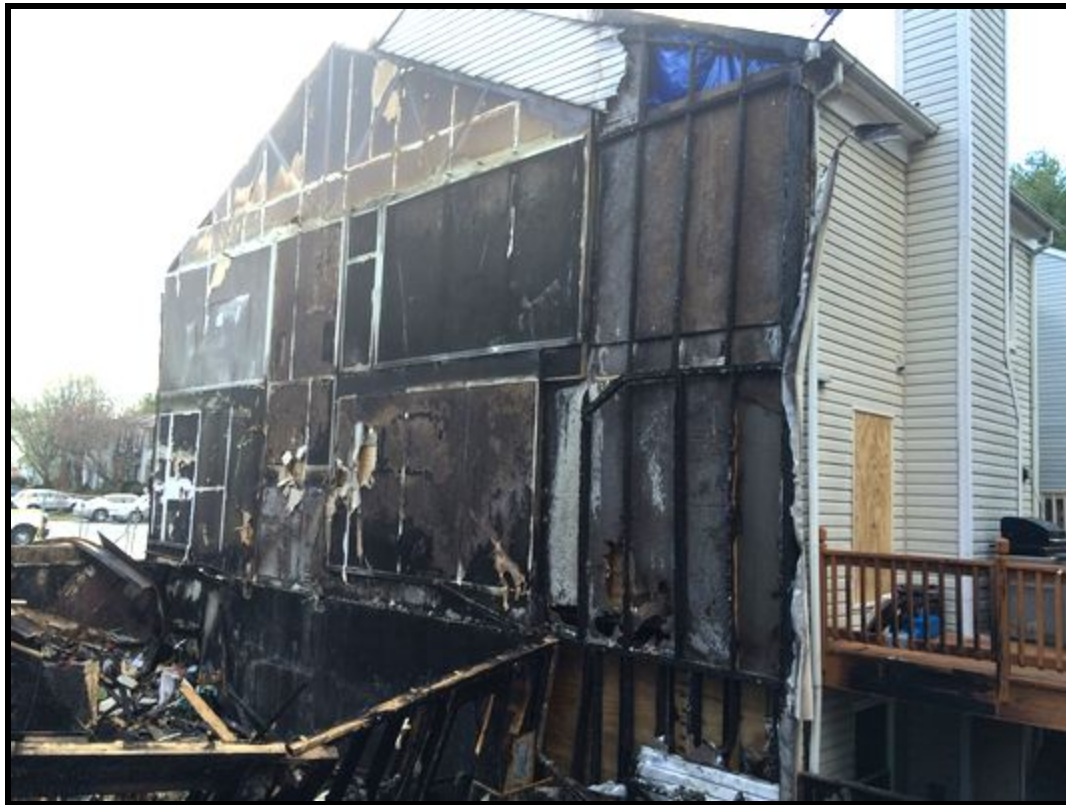
A view of the aftermath from Side Charlie

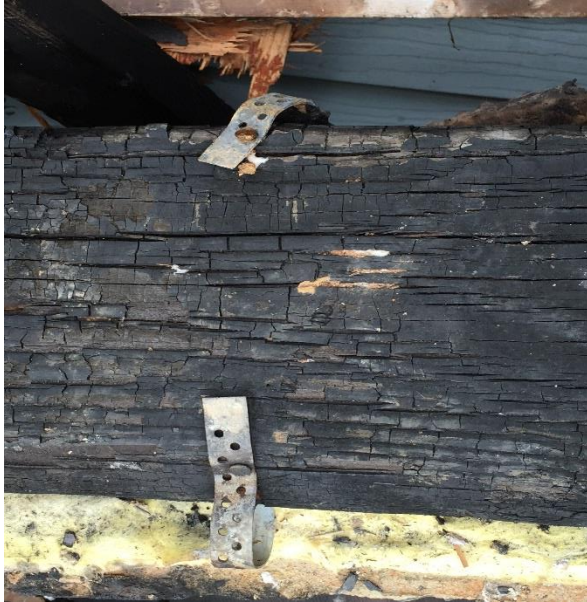
Fire Building - Sill plate with strapping present

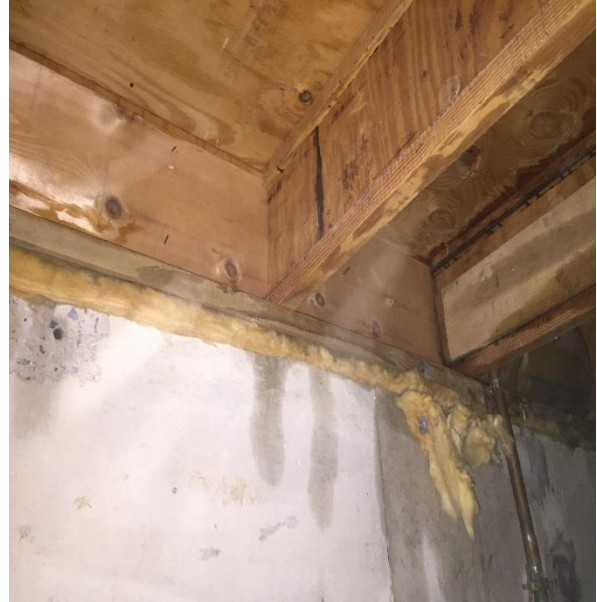
Exposure B – Proper joist framing

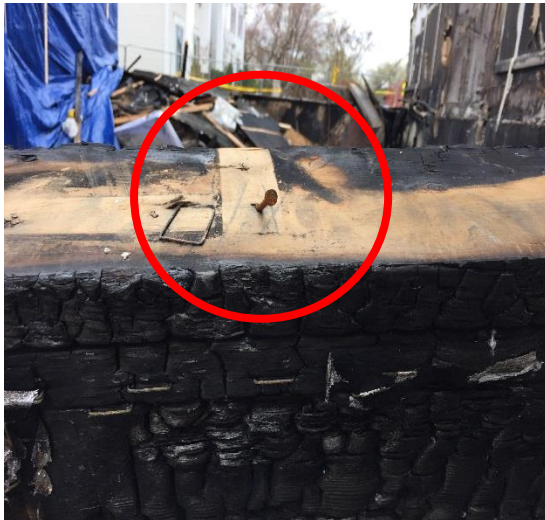
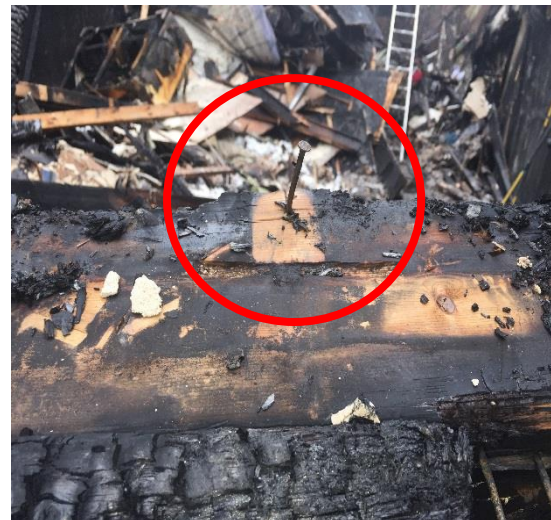
ranges from 10d (3" nail) to a 16d (3 ½" nail) and greatly depends on the size of the upper and bottom flange. An interesting item to note was that several nails were noticed on the front band board of the Churubusco Lane structure with only an average of ¾" embedment through the 2x12 band board and into the floor joist. This could indicate that the nails were smaller than the manufacture recommendations and could also indicate poor attachment of the band board to the joist flange. If poor nail embedment was a legitimate concern, then it could be assumed that the likelihood of the band board pulling away from the floor joist would increase at a time when the structure is significantly compromised. The image below shows where a pre-existing floor joist were "toe" nailed into the sill plate

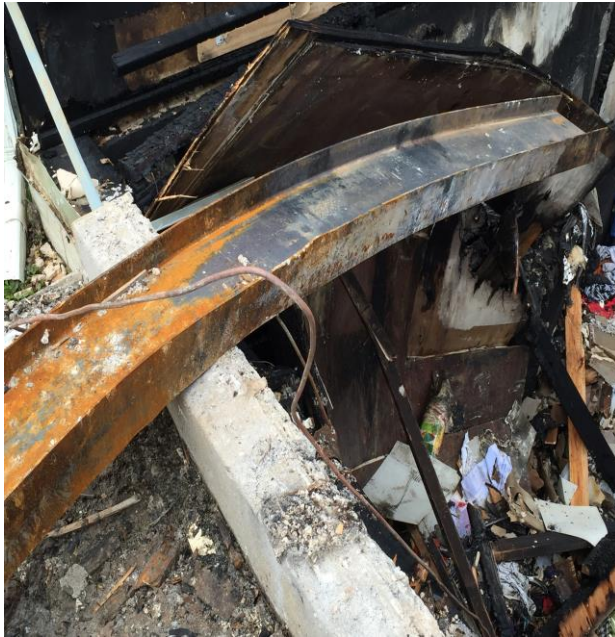
Generally, steel I beams will begin to show signs of failure once temperatures reach 1000-1100 degrees. Extreme heat exposure will cause the steel to elongate and lose its shape. Features that indicate possible high heat exposure and structural compromise of the I beam were evident. One of the I beams, when removed from the structure, presented with a warped shape as well as heat stress markings. It would be assumed, based on the appearance of the beam and the fire conditions at the time of this incident, that the I beam was compromised and aided in the deterioration of the structure.

Note: Bowed Appearance of Beam

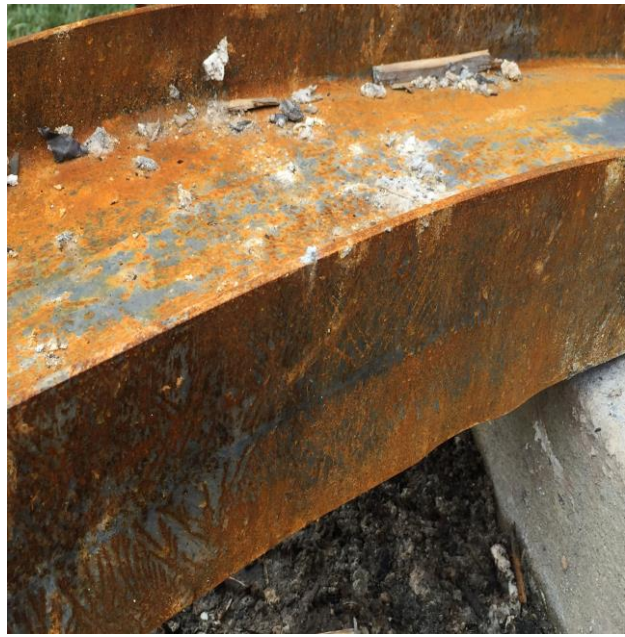
Note: Stress Markings from High Heat Exposure

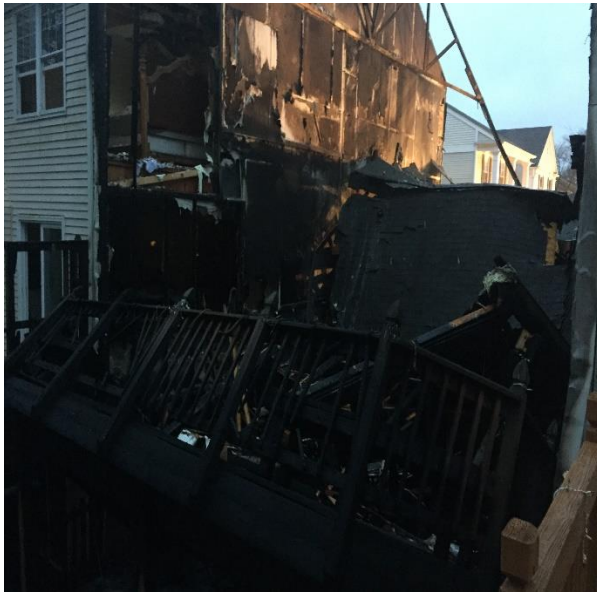
Failed Deck

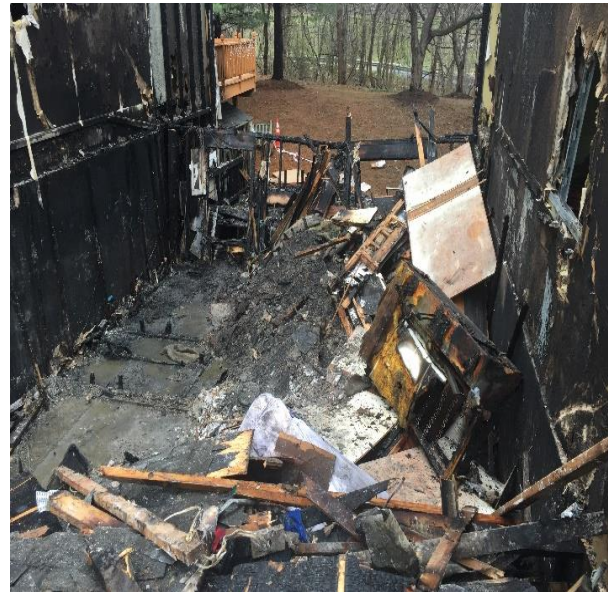
Failed Exterior Wall – Note – Leaning Outwards

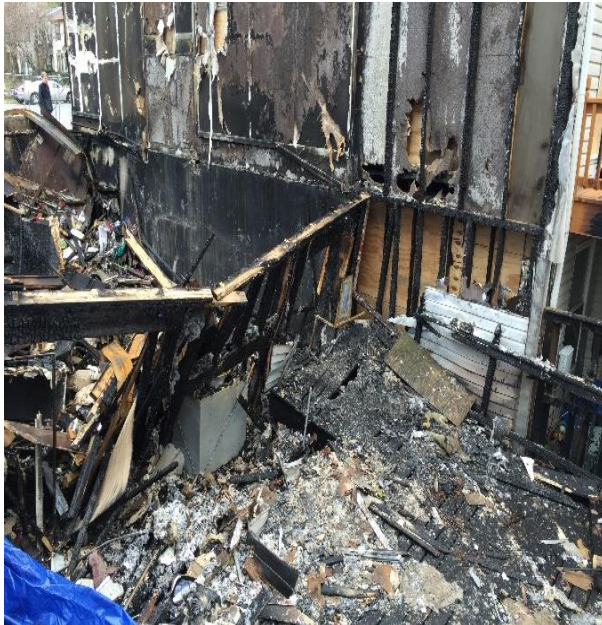
Failed Exterior Wall – Leaning Outwards

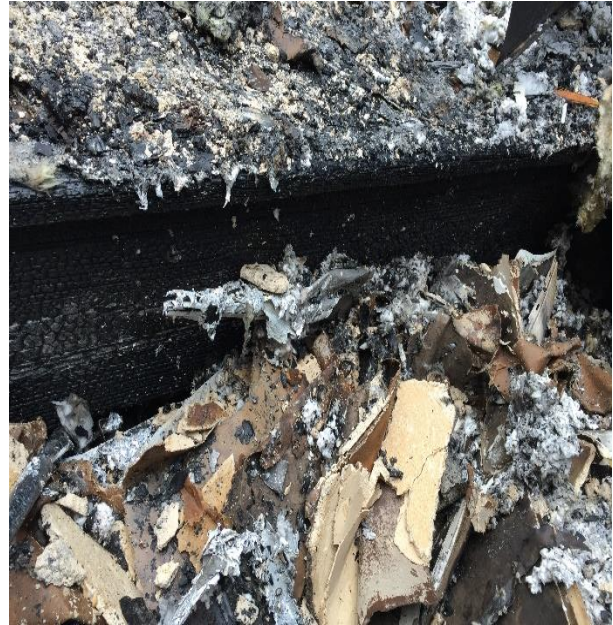
- Nail embedment where the band boards connected to the floor joist were marginal at best. Through the delayering process, it was witnessed on numerous occasions that there was an overall lack of proper nail connections into the floor joists. This could have contributed to the opportunity for the band board to easily separate from the joists. As stated above, the connections did not appear to be within the manufacture recommendations for proper nail size or embedment.
- Although the collapse was catastrophic and involved a complete collapse of the entire structure, it is believed that this unit failed as designed. The platform style system failed due to a lack of proper supporting mechanisms. The collapse was isolated to the compromised structure only and did not necessarily compromise the structures in exposed areas.

Deck Band Board – Note – No Visible Bolts / Lags

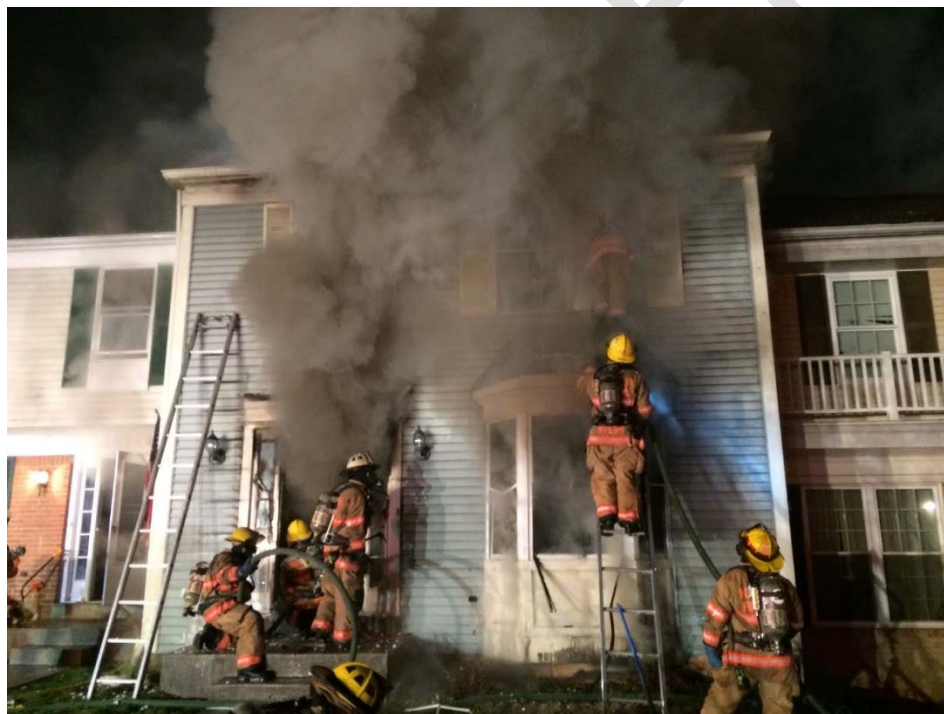
Figure 1 -19350 Churubusco Lane Moments Prior To Collapse
